THE PROBLEMS OF INDUSTRIAL 3D ABS AND PLA PRINTERS IN CERMISO CENTER

Abstract - Within the CERMISO INCDMTM Bucharest center, the study of drones requires, among other processing equipment, the use of a high-volume industrial plastic 3D printer. This is the reason why the center was equipped with a JCR 1000 Dual printer with a 1000 x 600 x 600 mm printing volume (insulated and heat-controlled), two printheads, closed enclosure and heat-controlled bed. In the period of about two years since the acquisition of this industrial equipment, we have performed tests, trials and research on this model of 3D printer, so we have reached a series of problems that can be solved for a more safe and precise operation. The problems and the related solutions found are presented in this paper.

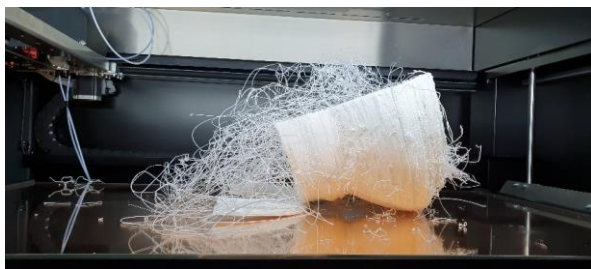
Figure 2: A piece badly completed due to some voltage spikes and transients in the electric power supply

The ABS and PLA industrial 3D printer from SICNOVA JCR1000, is directly connected to the electrical network of the INCDMTM - Bucharest Institute. Unfortunately, voltage spikes and transients periodically appear during longer 3D print jobs, the machine tends to lose its reference, and the printer continues to deposit layer upon layer but in a different location than the one set according to the 3D drawing, resulting in parts similar to those presented in Figure 2.

After several studies and research, we came to the conclusion that this industrial 3D printer has no built-in electrical protection from the factory against these electrical problems. This important aspect leads to very large losses of material and time, especially during the 3D printing of very large parts, so we need to reprint the same job.

The equipment must be powered thru an original special filter designed and created in INCDMTM, the DF filter (approved in 1999). It's main purpose is to cut off the voltage spikes and transients witch unfortunately pass through normal UPS, internal Power Sources and finish into the mainboards of the equipment sometimes even destroying lot of electronic parts.

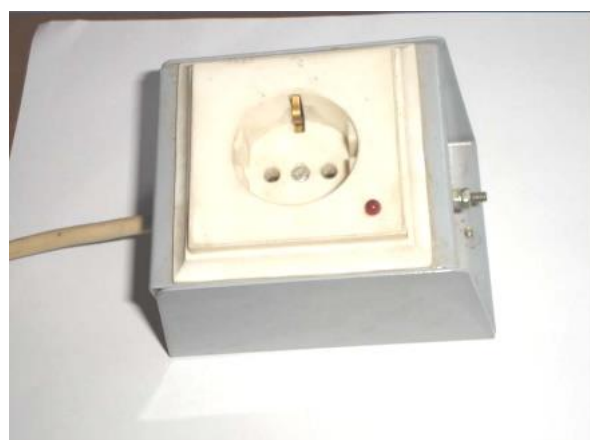
Figure 3: The DF filter

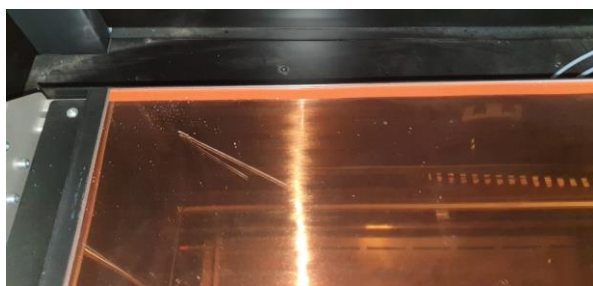
When voltage drops occur for longer periods of time, due to the high weight of the printing bed, it falls slowly to the minimum control limit with a very high possibility of rotating it around the axis between the two electric motors. In most cases, the back of the printer bed is higher. Having no control or ability to observe this level difference in the surface of the printing bed, there is a very high possibility that when you start a new 3D printing job, to lose the equipment calibration (“the thickness of the sheet of paper”) made in 49 points, and thus the nozzle hits and scratches the glass of the printing bed. These above effects can lead to very large damage to the printing bed by puncturing the glass and scratching it, as can be seen in Figure 5.

Figure 5: The extruder hits and scratches the print bed

In conclusion, for this problem related to power outages, the manufacturer states in the equipment file that there is an intelligent system for managing the power. This intelligent system is an advanced UPS that offers long life, to continue printing in normal parameters in case of a power failure. After a while, the system shuts down in a controlled manner, saving the printer parameters, announcing the incident, and the operator can then resume the print from where it left off.

The dedicated UPS is able to communicate directly with the printer but unfortunately it is very expensive.

We manage to solve this problem in order to use any intelligent UPS that can provide a power of 2000W. The UPS power both the JCR 1000 equipment and the command-and-control laptop. But this time the smart connection is made between laptop and UPS. And by default, all orders will be given this time from laptop to printer. This avoids the need to buy the original equipment that comes with the printer, which is extremely expensive.
